# Peaks of Otter

## Soil & Water Conservation District

Big Otter River Watershed spans Bedford and Campbell Counties

# How is the water quality in Big Otter R. watershed?

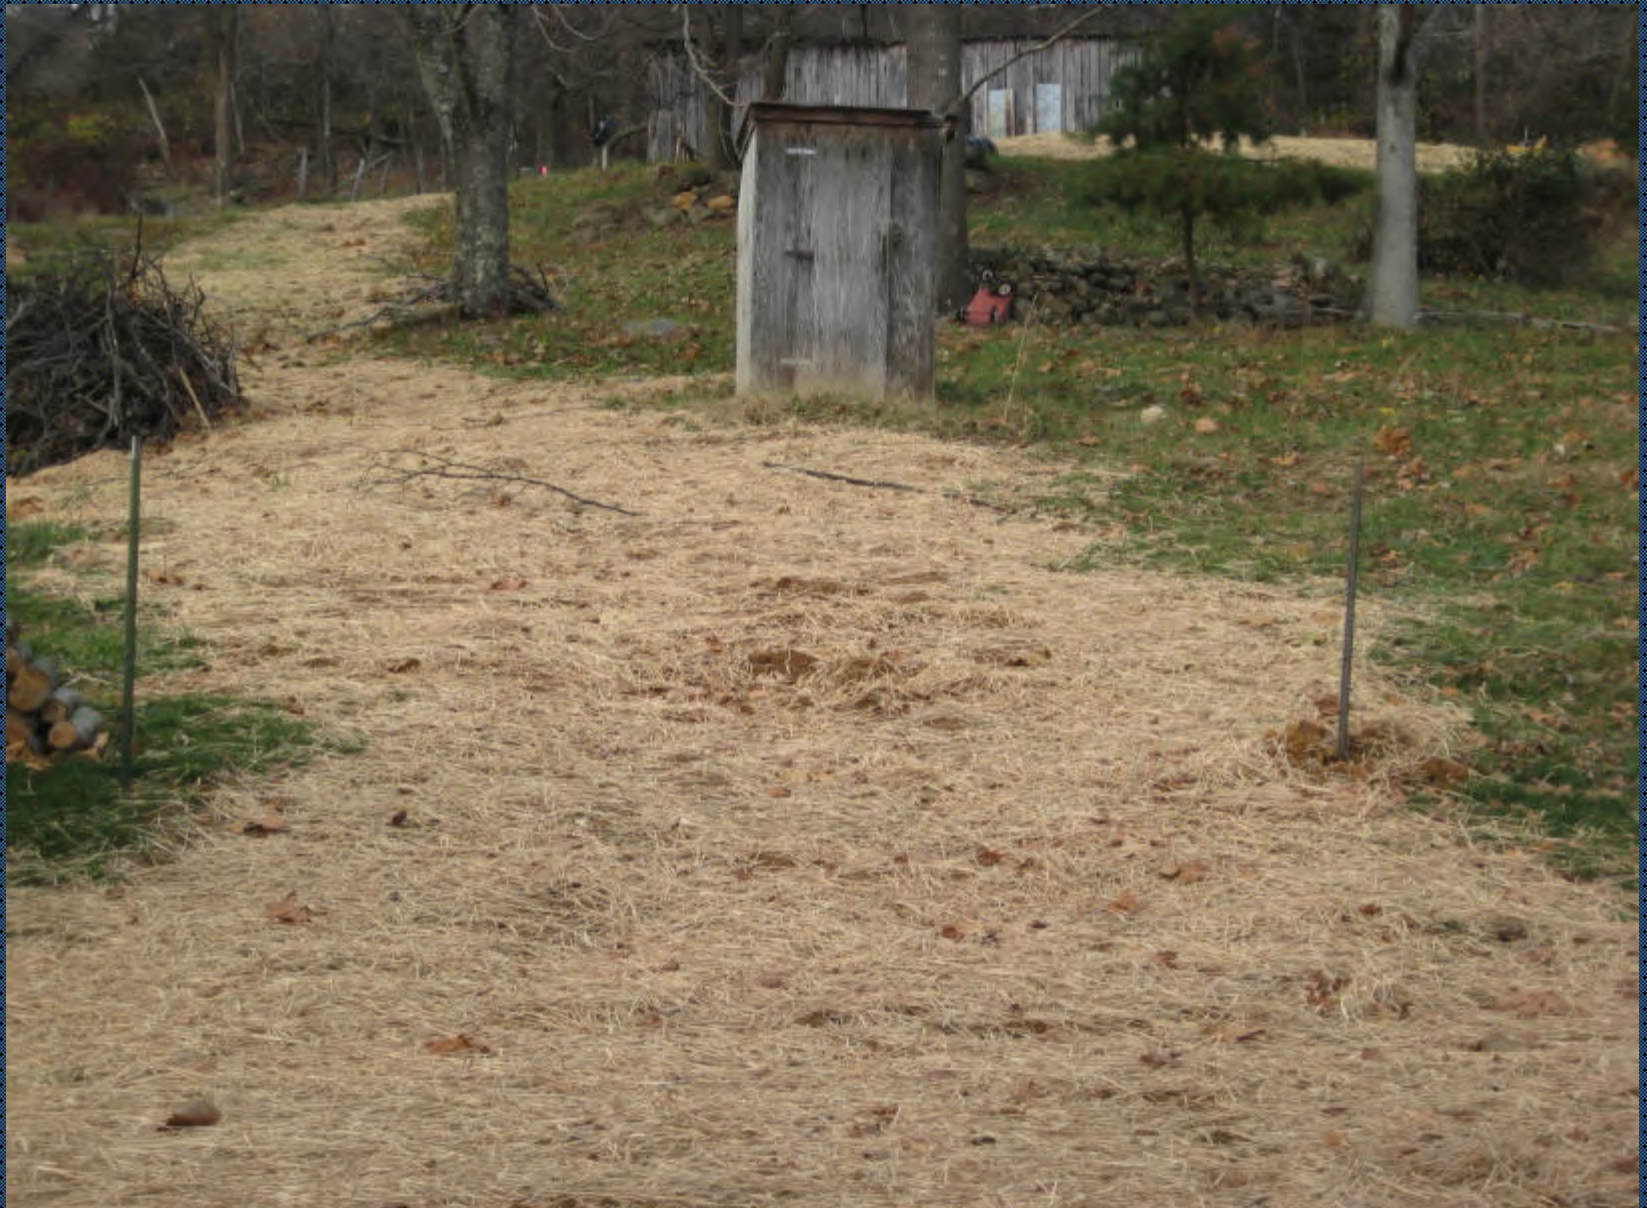
## Completed RB-4P

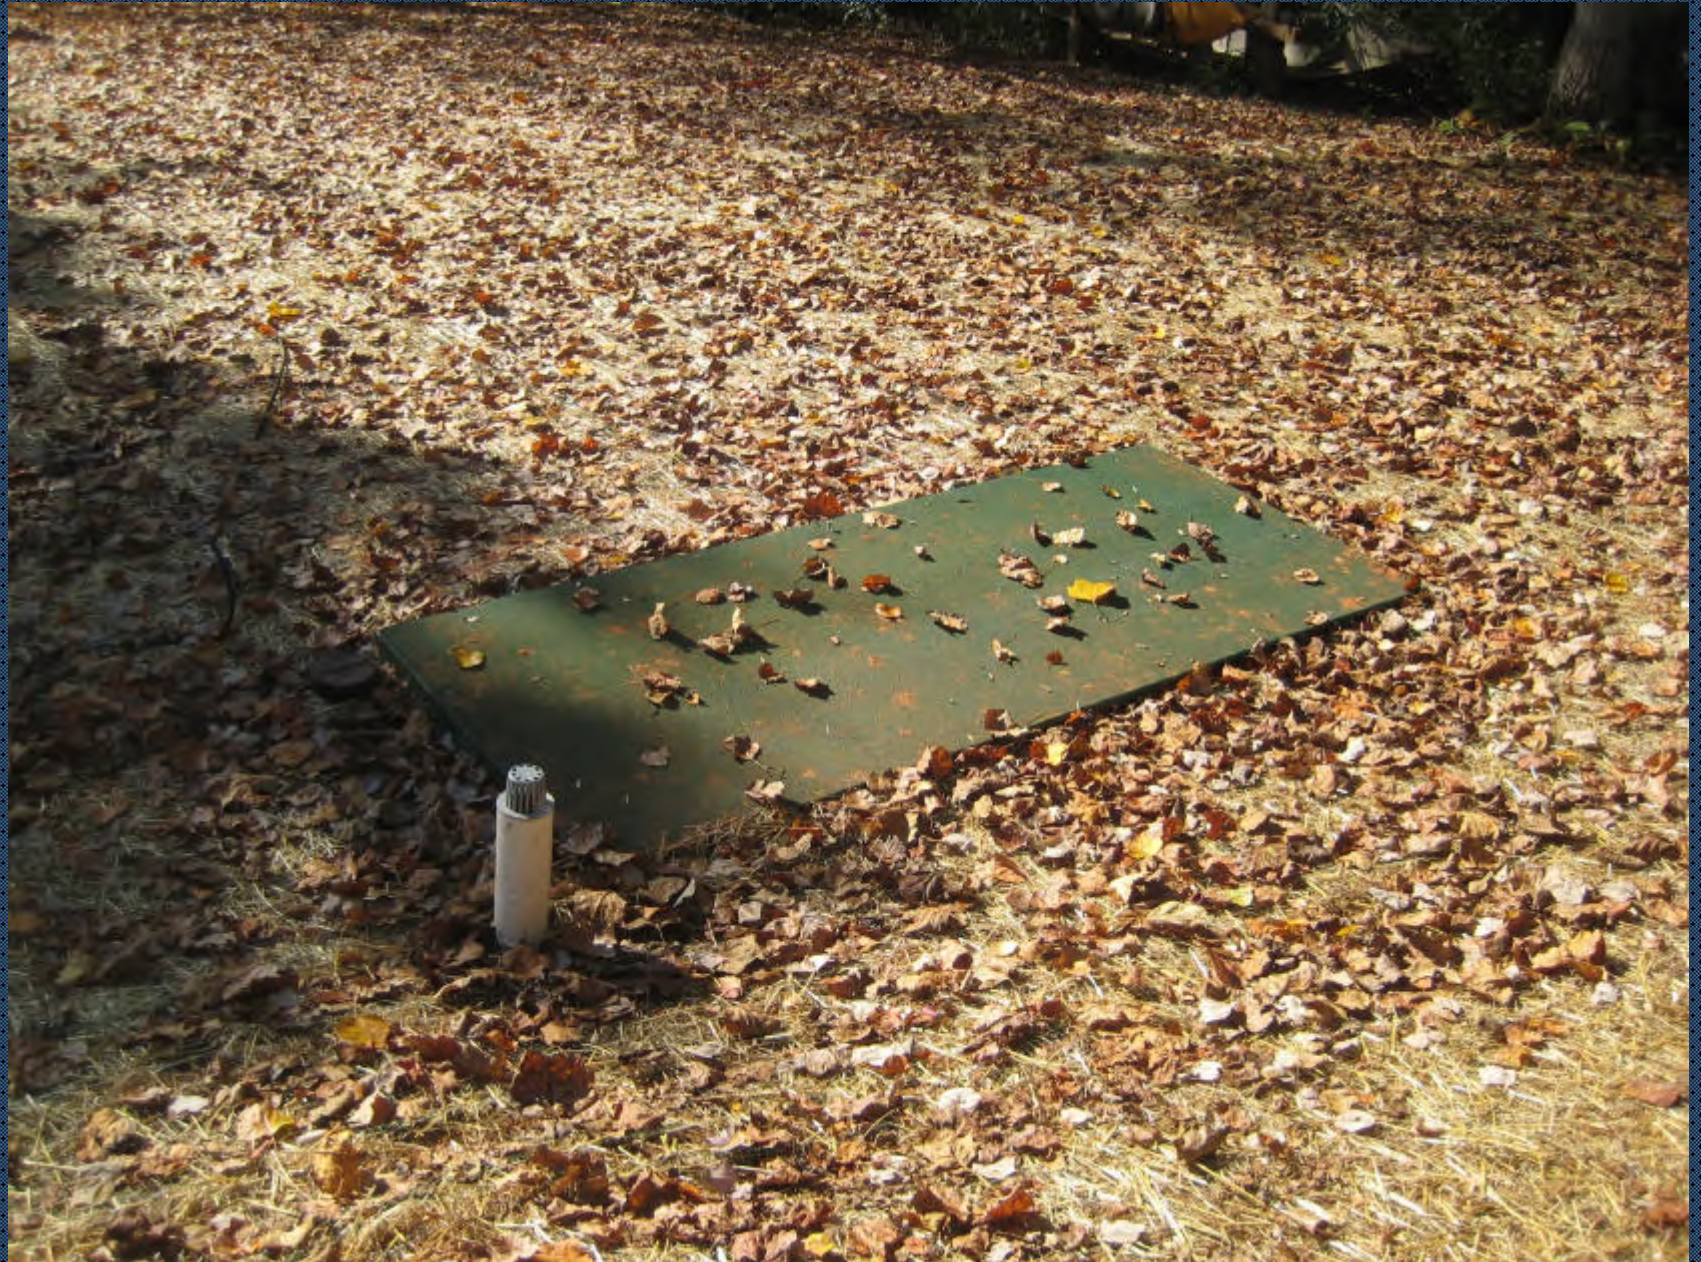
## Completed RB-5 System

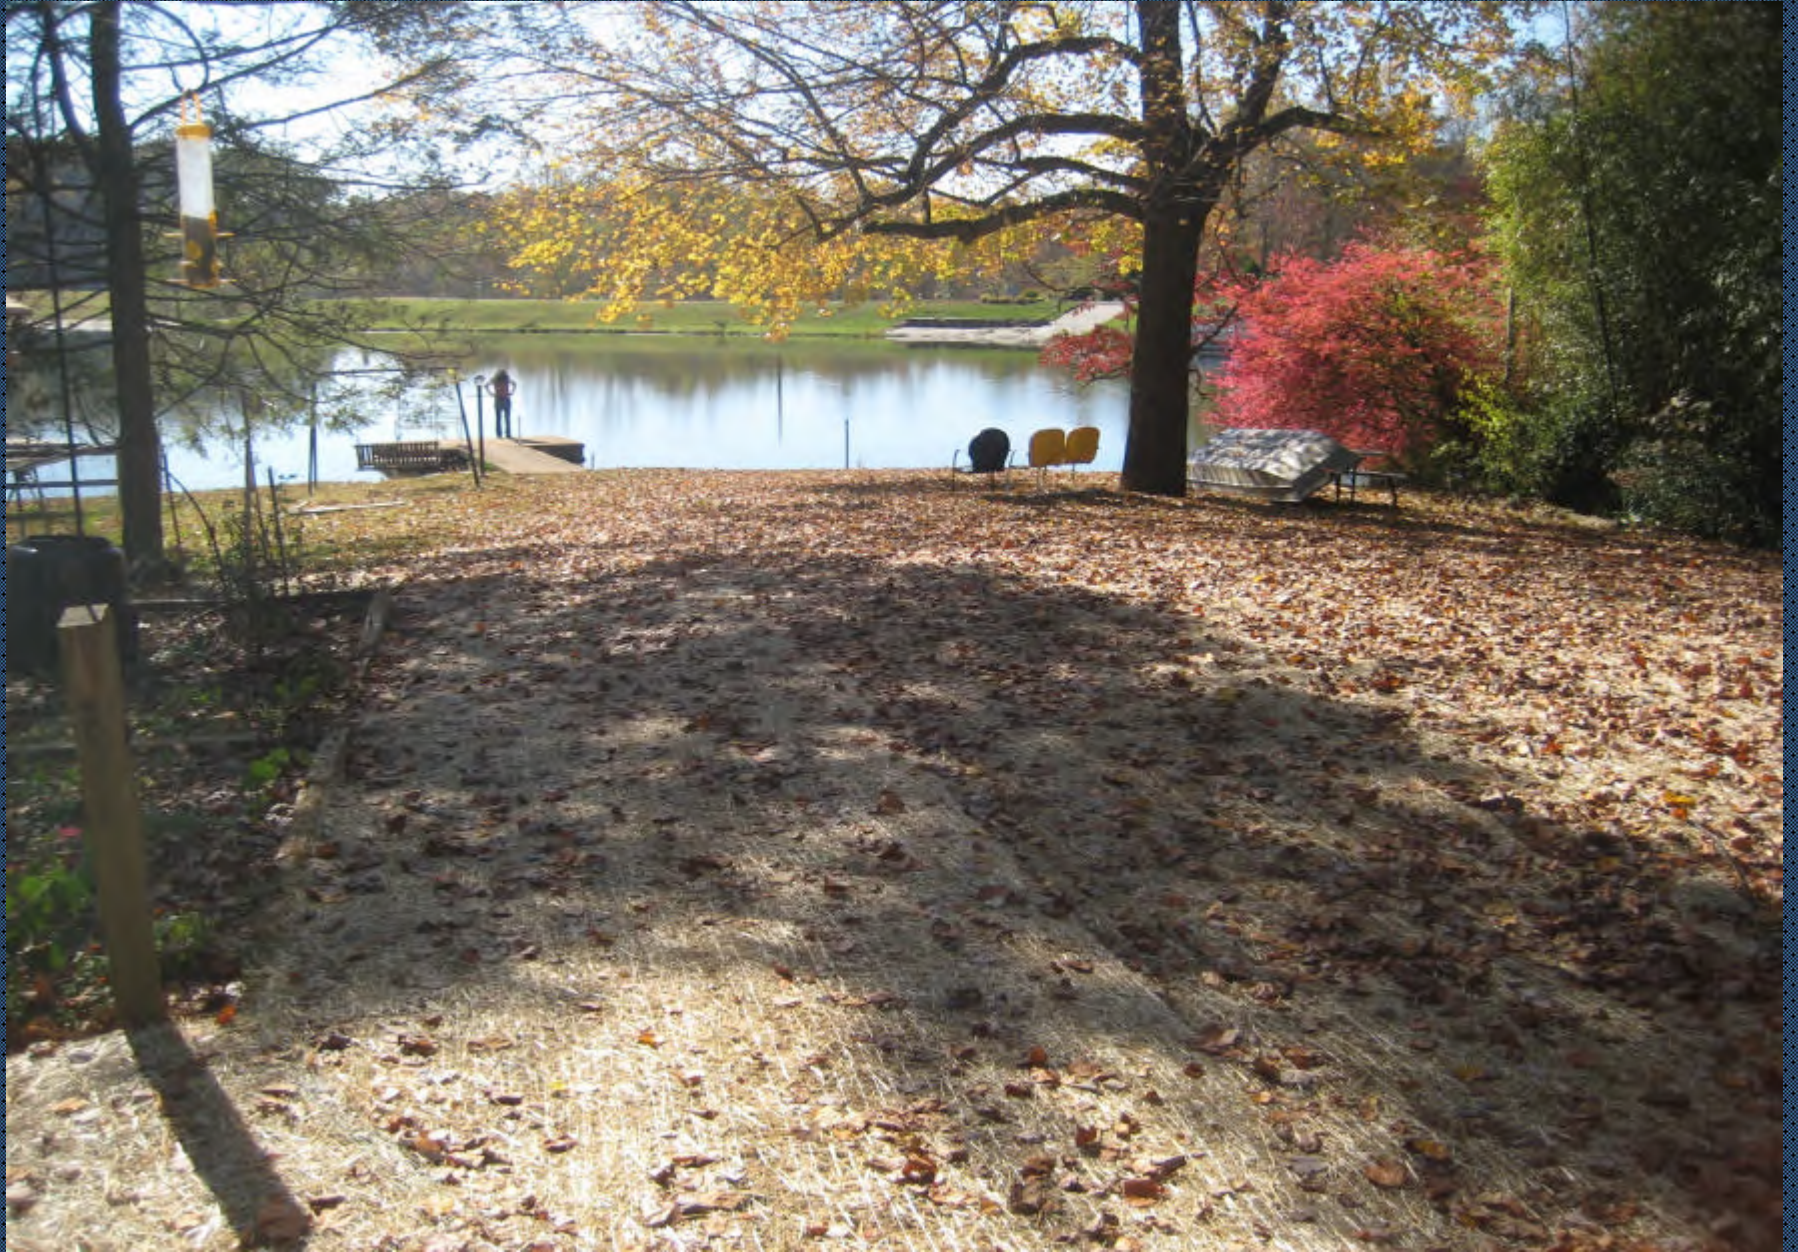
## RB-5 Re-Seeding

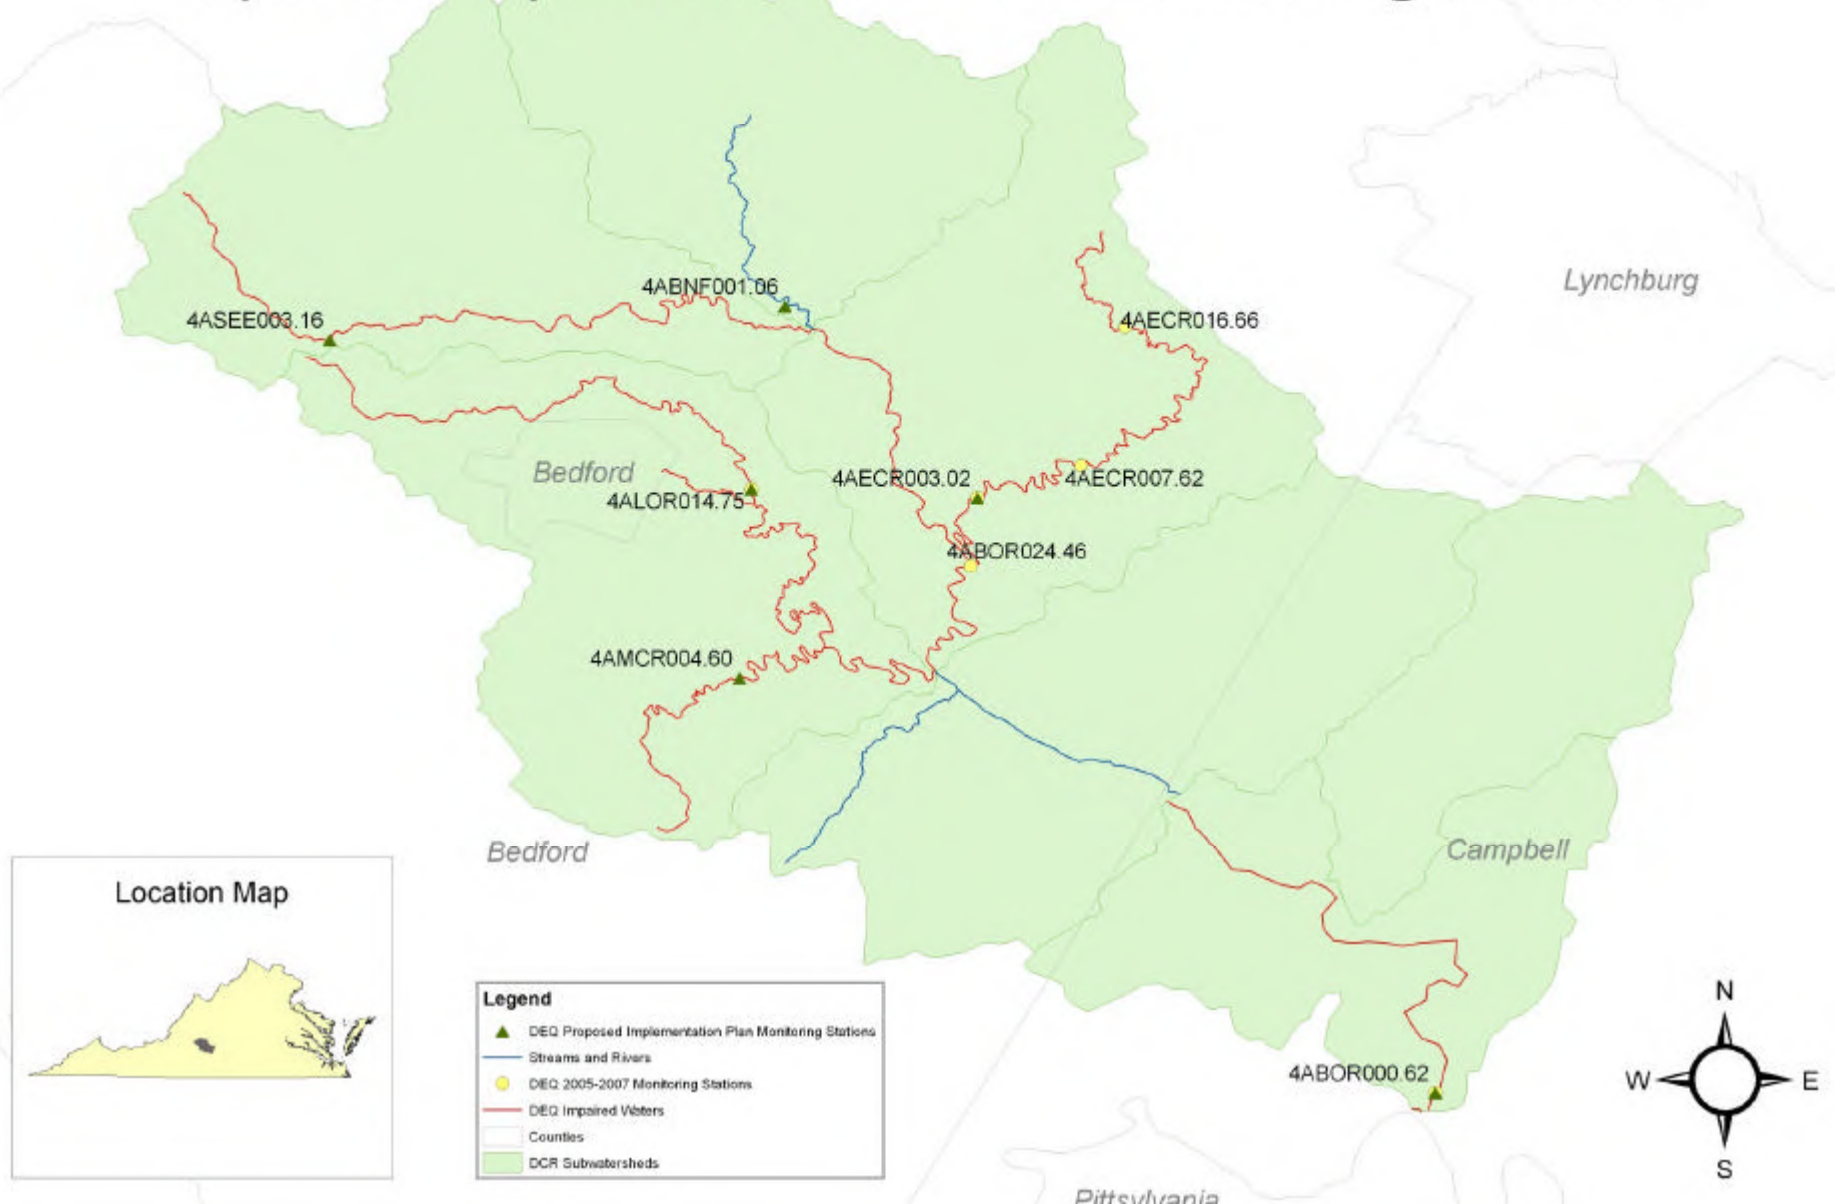
## Proposed Implementation Plan Monitoring Stations

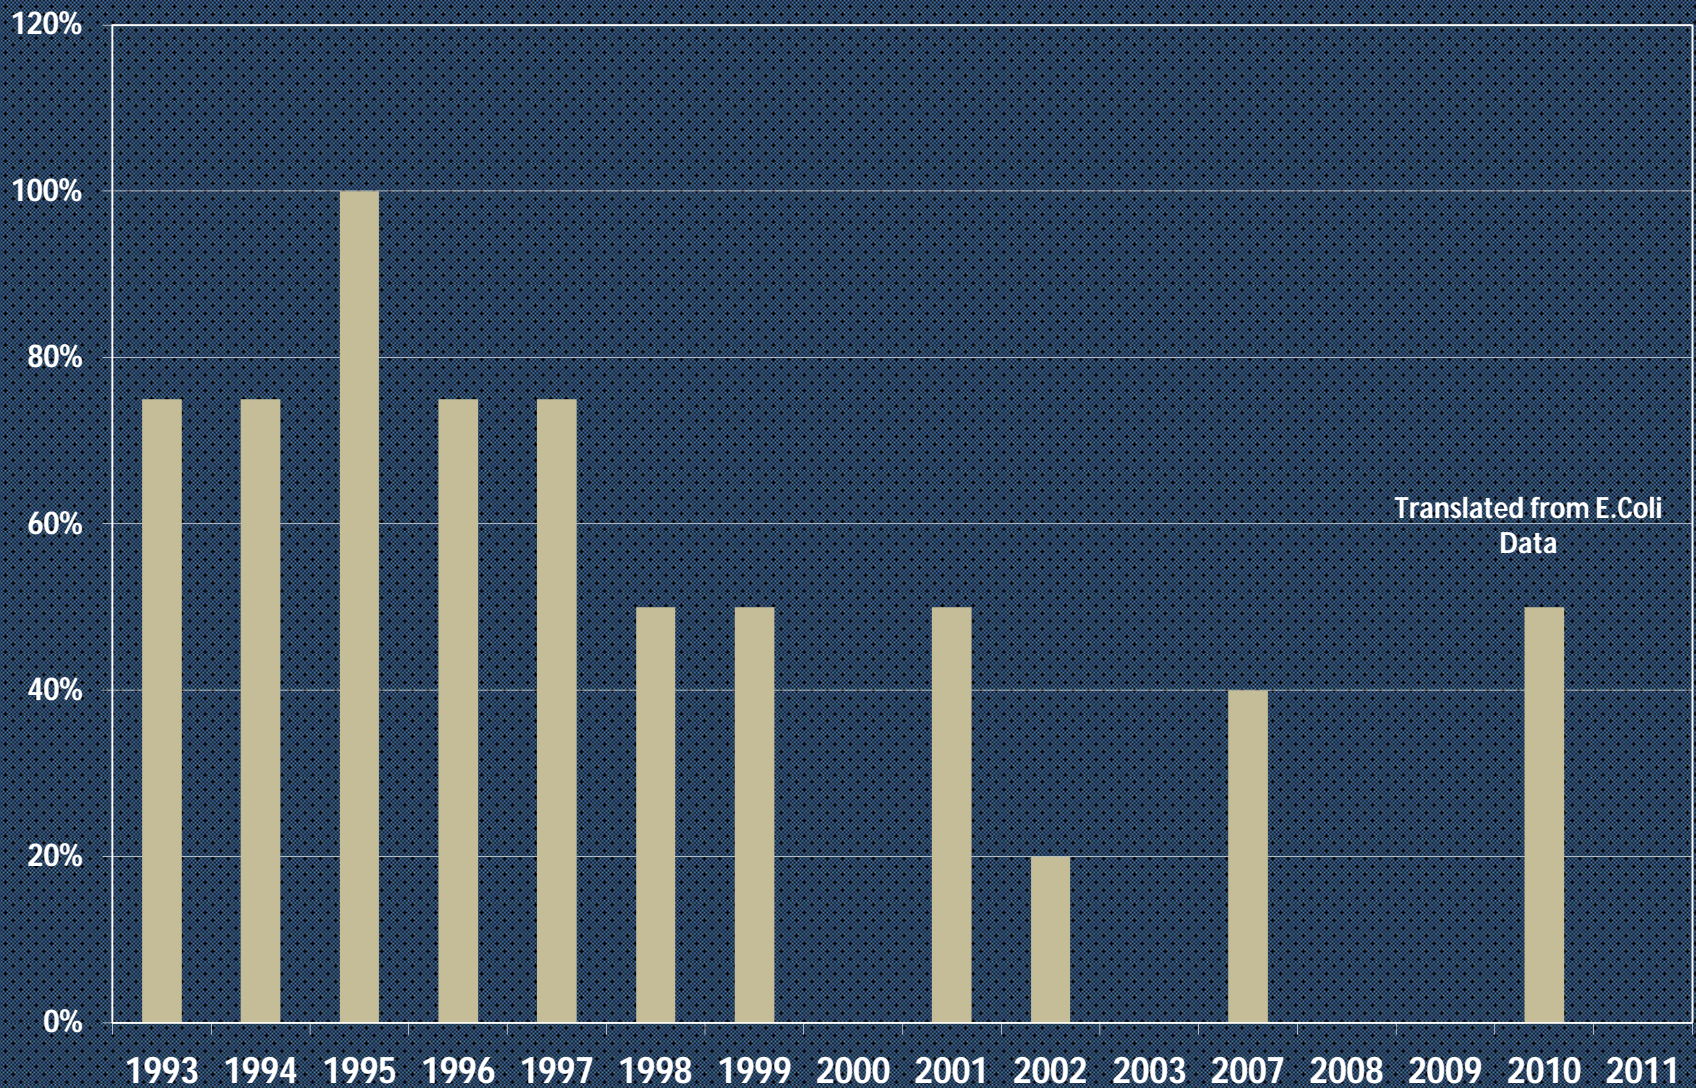
# Fecal Coliform Interim Standard (400 cfu/100mL) Violation Rate at Sheep Creek station 4ASEE003.16 (1990 – 2011)

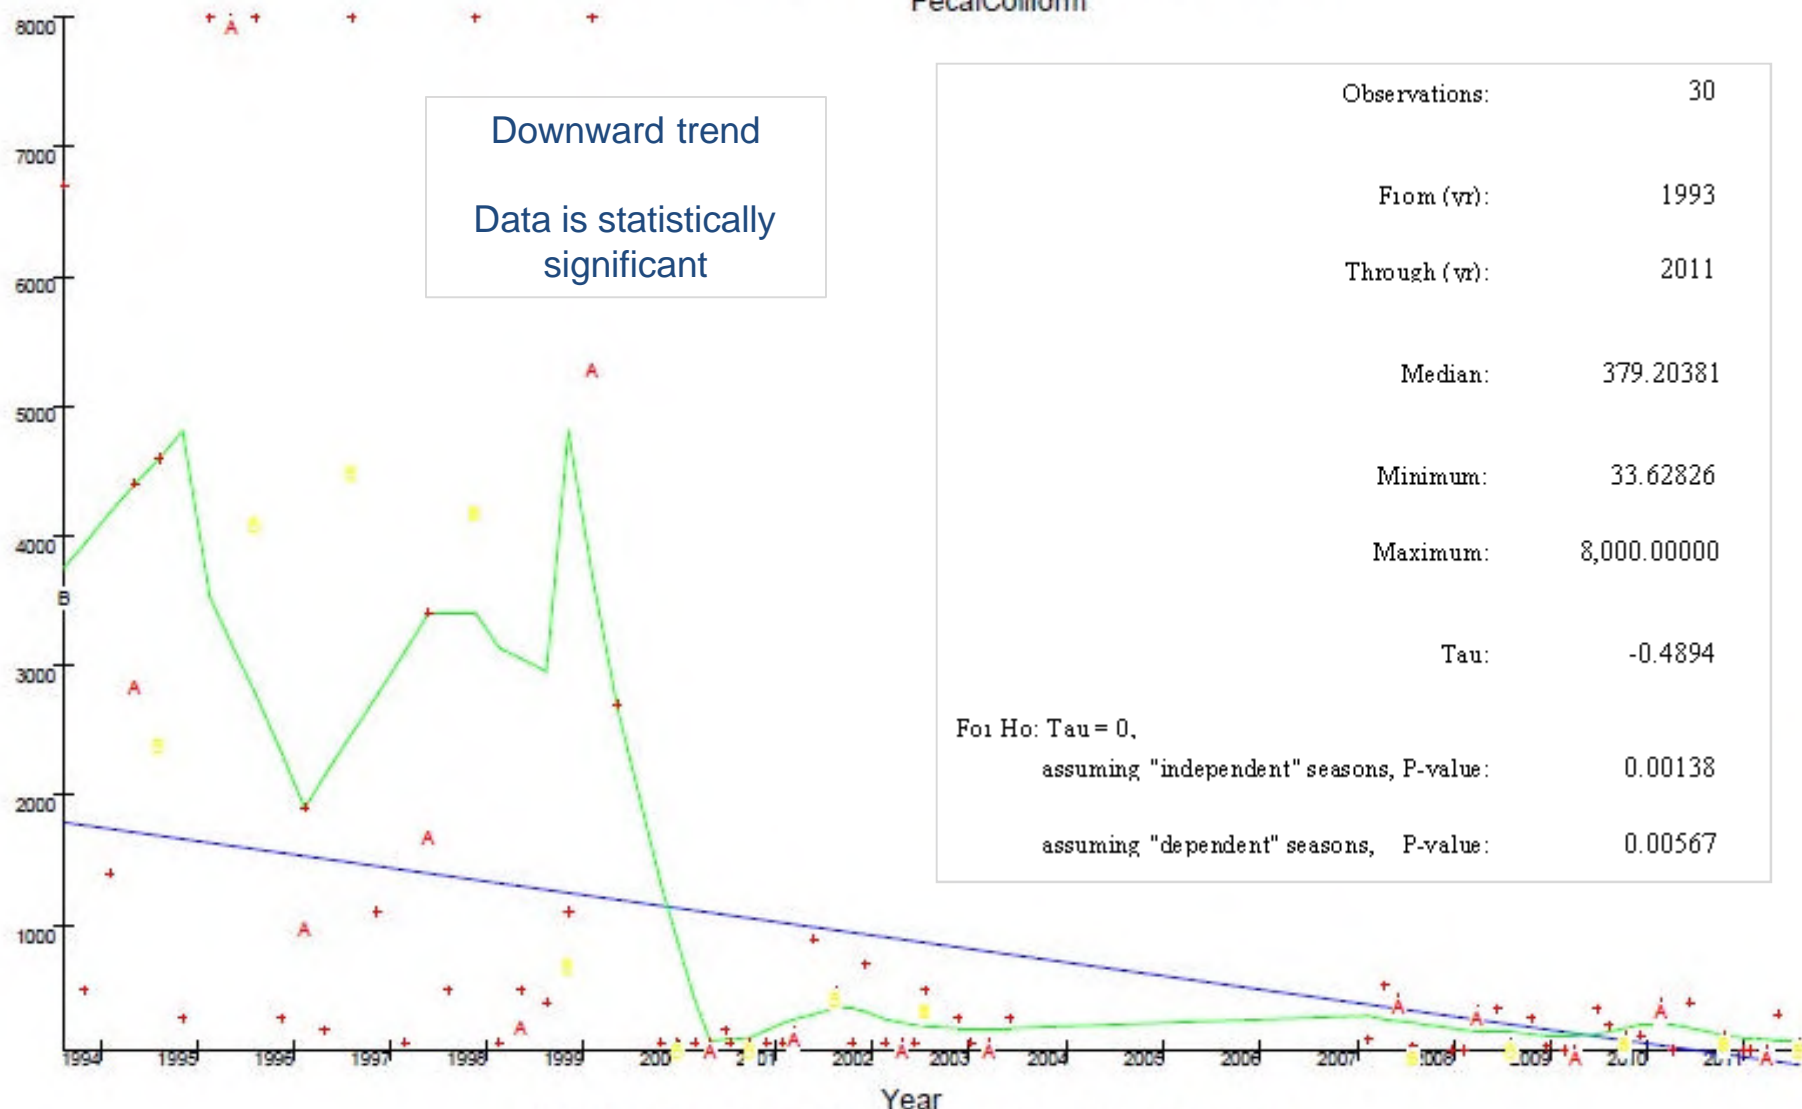
# Station 4ASEE003.16, FecalColiform

Tau = -0.489362, Ind-P = 0.001377, Dep-P = 0.005674, Slope = -103.512 (Record sheeptrend)

Downward trend

Data is statistically significant

Observations: 30

Median: 379.20381

NOTE: Original Data are red. Reduced to medians data are colored symbols.

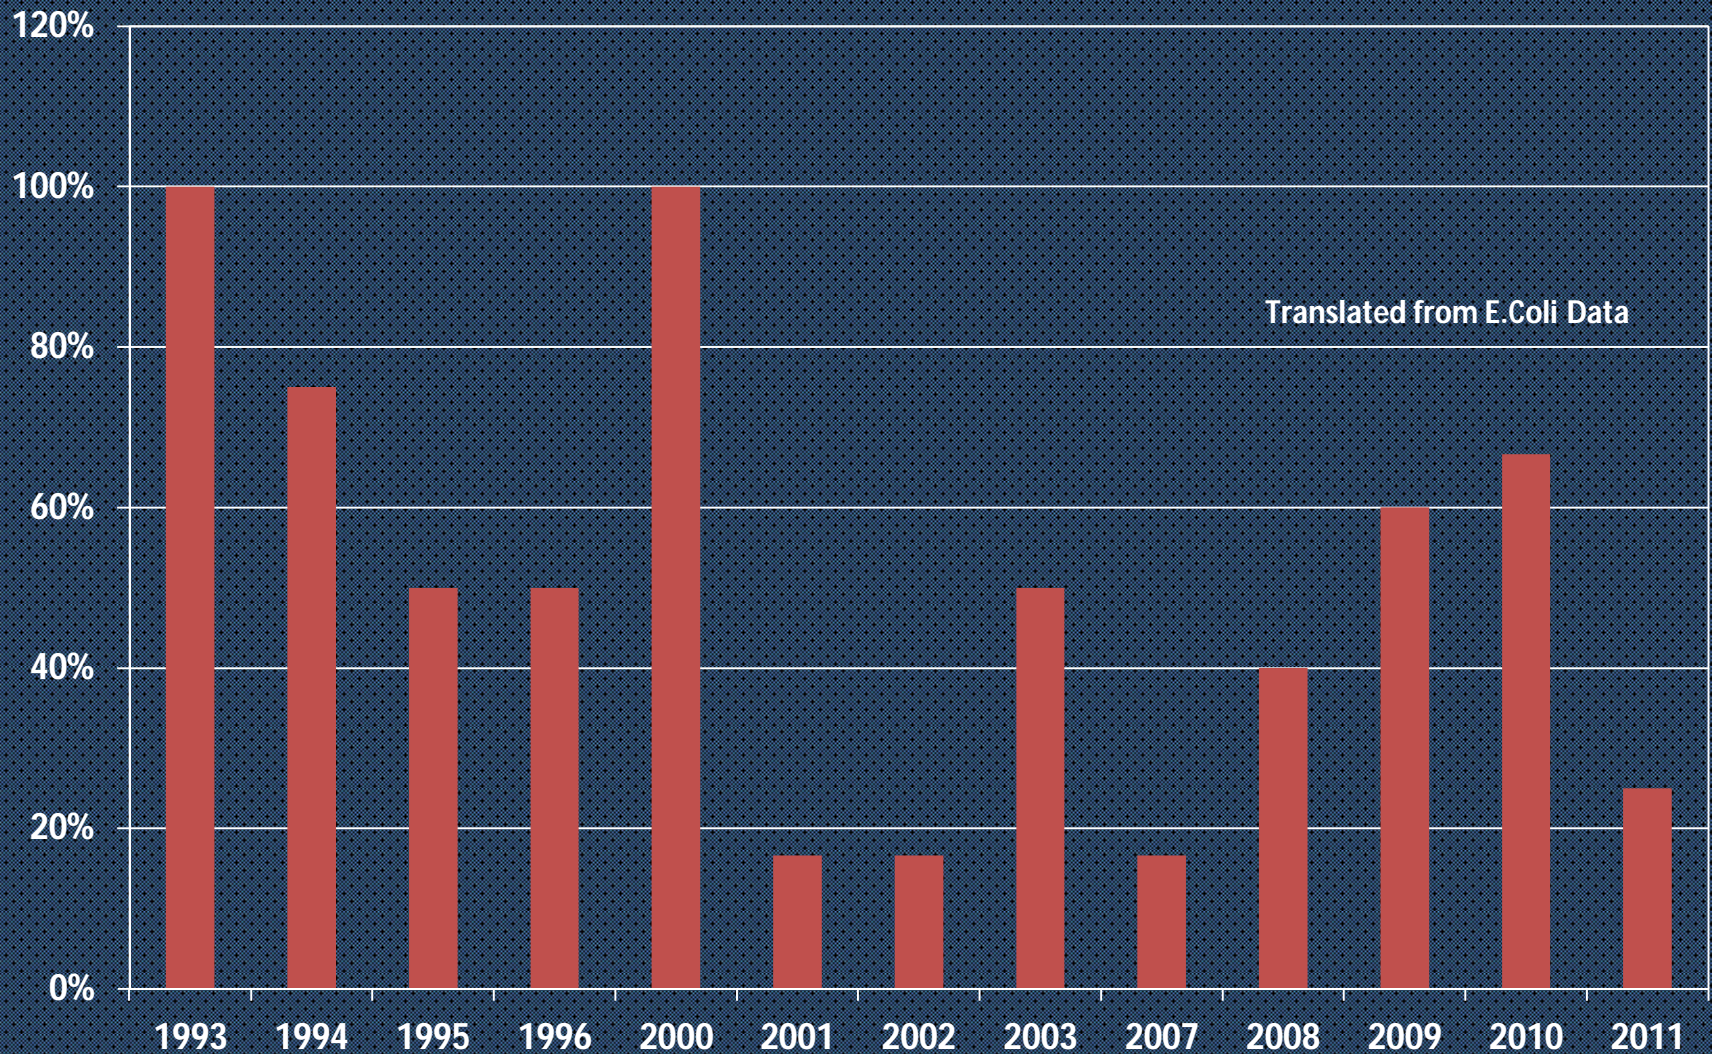
# Fecal Coliform Interim Standard (400 cfu/100mL) Violation Rate at Machine Creek station 4AMCR004.60 (1990 – 2011)

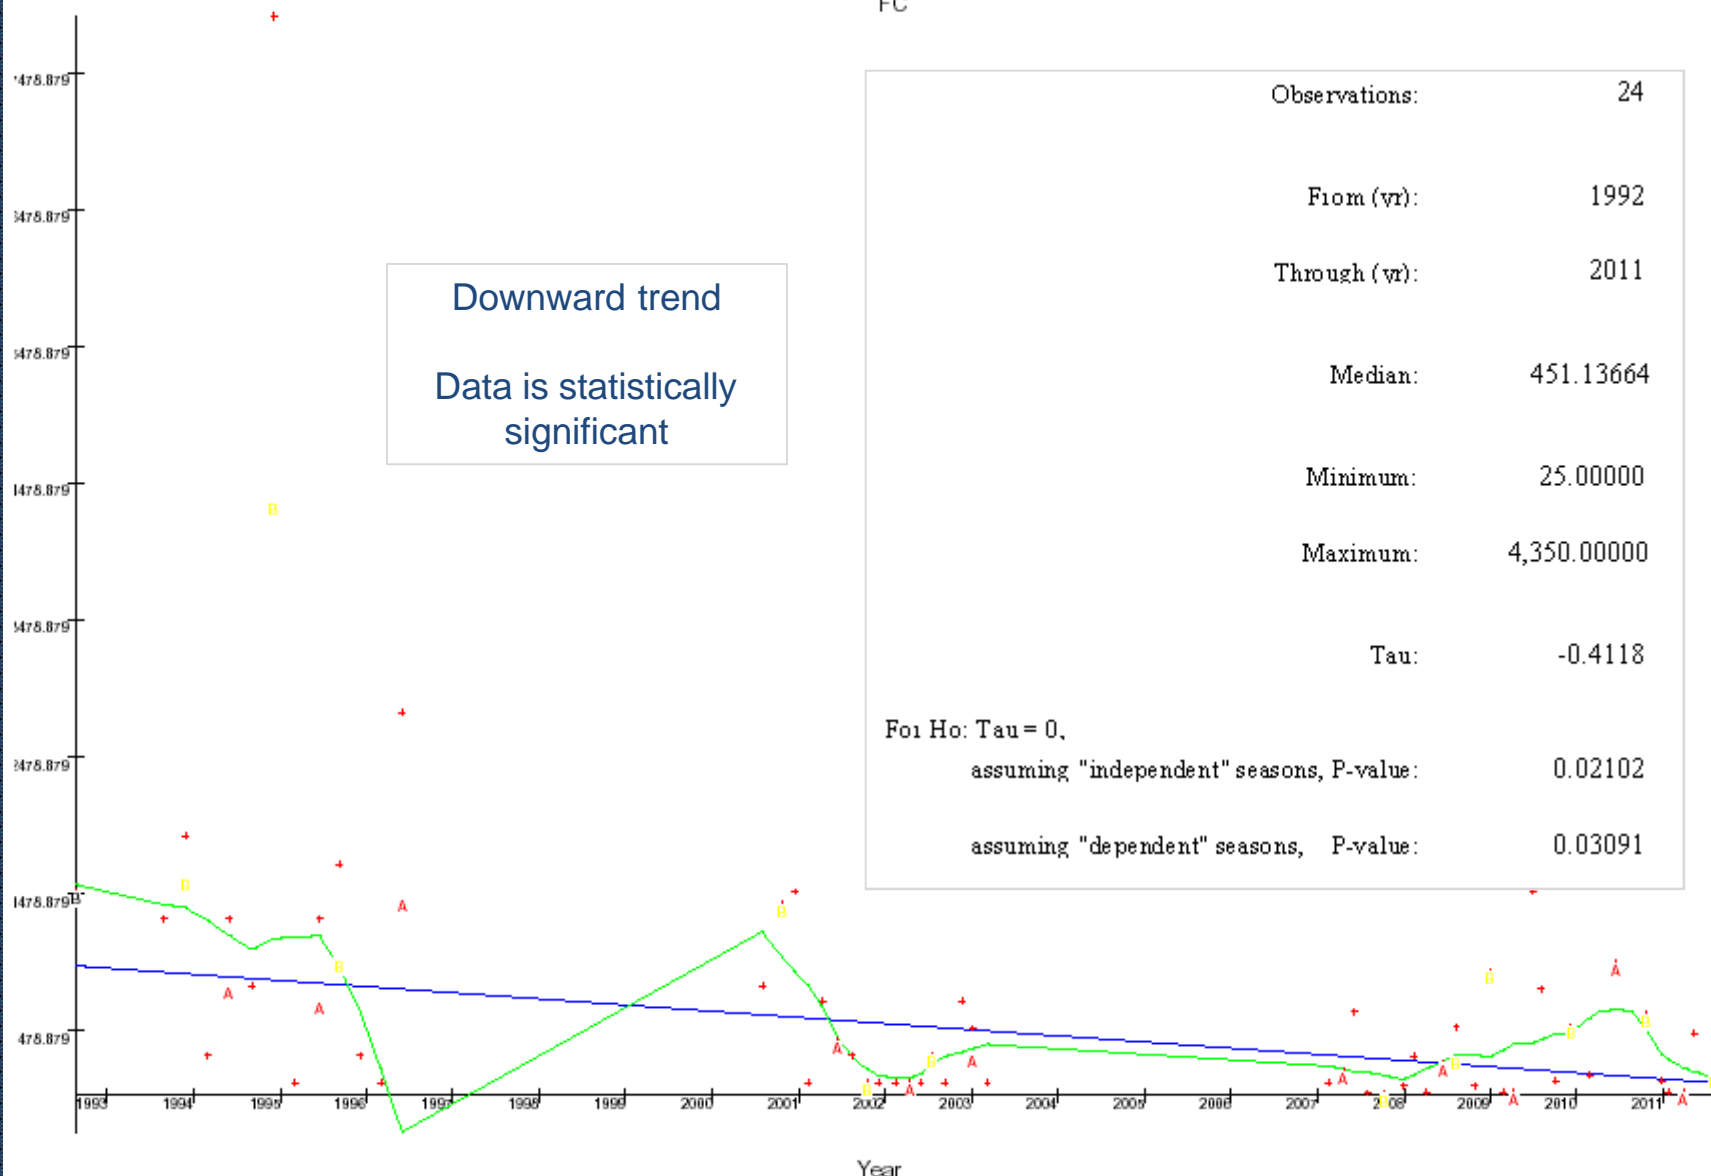
Station 4AMCR004.60, FC  
 Tau = -0.411765, Ind-P = 0.021020, Dep-P = 0.030915, Slope = -45.0807 (Record machine)  
 Datafile: linker, Dataset: machine, # seasons: 2, Lowess Proportion (raw data): 0.15  
 FC

Downward trend  
 Data is statistically significant

Observations: 24  
 From (yr): 1992  
 Through (yr): 2011  
 Median: 451.13664  
 Minimum: 25.00000  
 Maximum: 4,350.00000  
 Tau: -0.4118  
 For Ho: Tau = 0,  
 assuming "independent" seasons, P-value: 0.02102  
 assuming "dependent" seasons, P-value: 0.03091

NOTE: Original Data are red. Reduced to medians data are colored symbols.

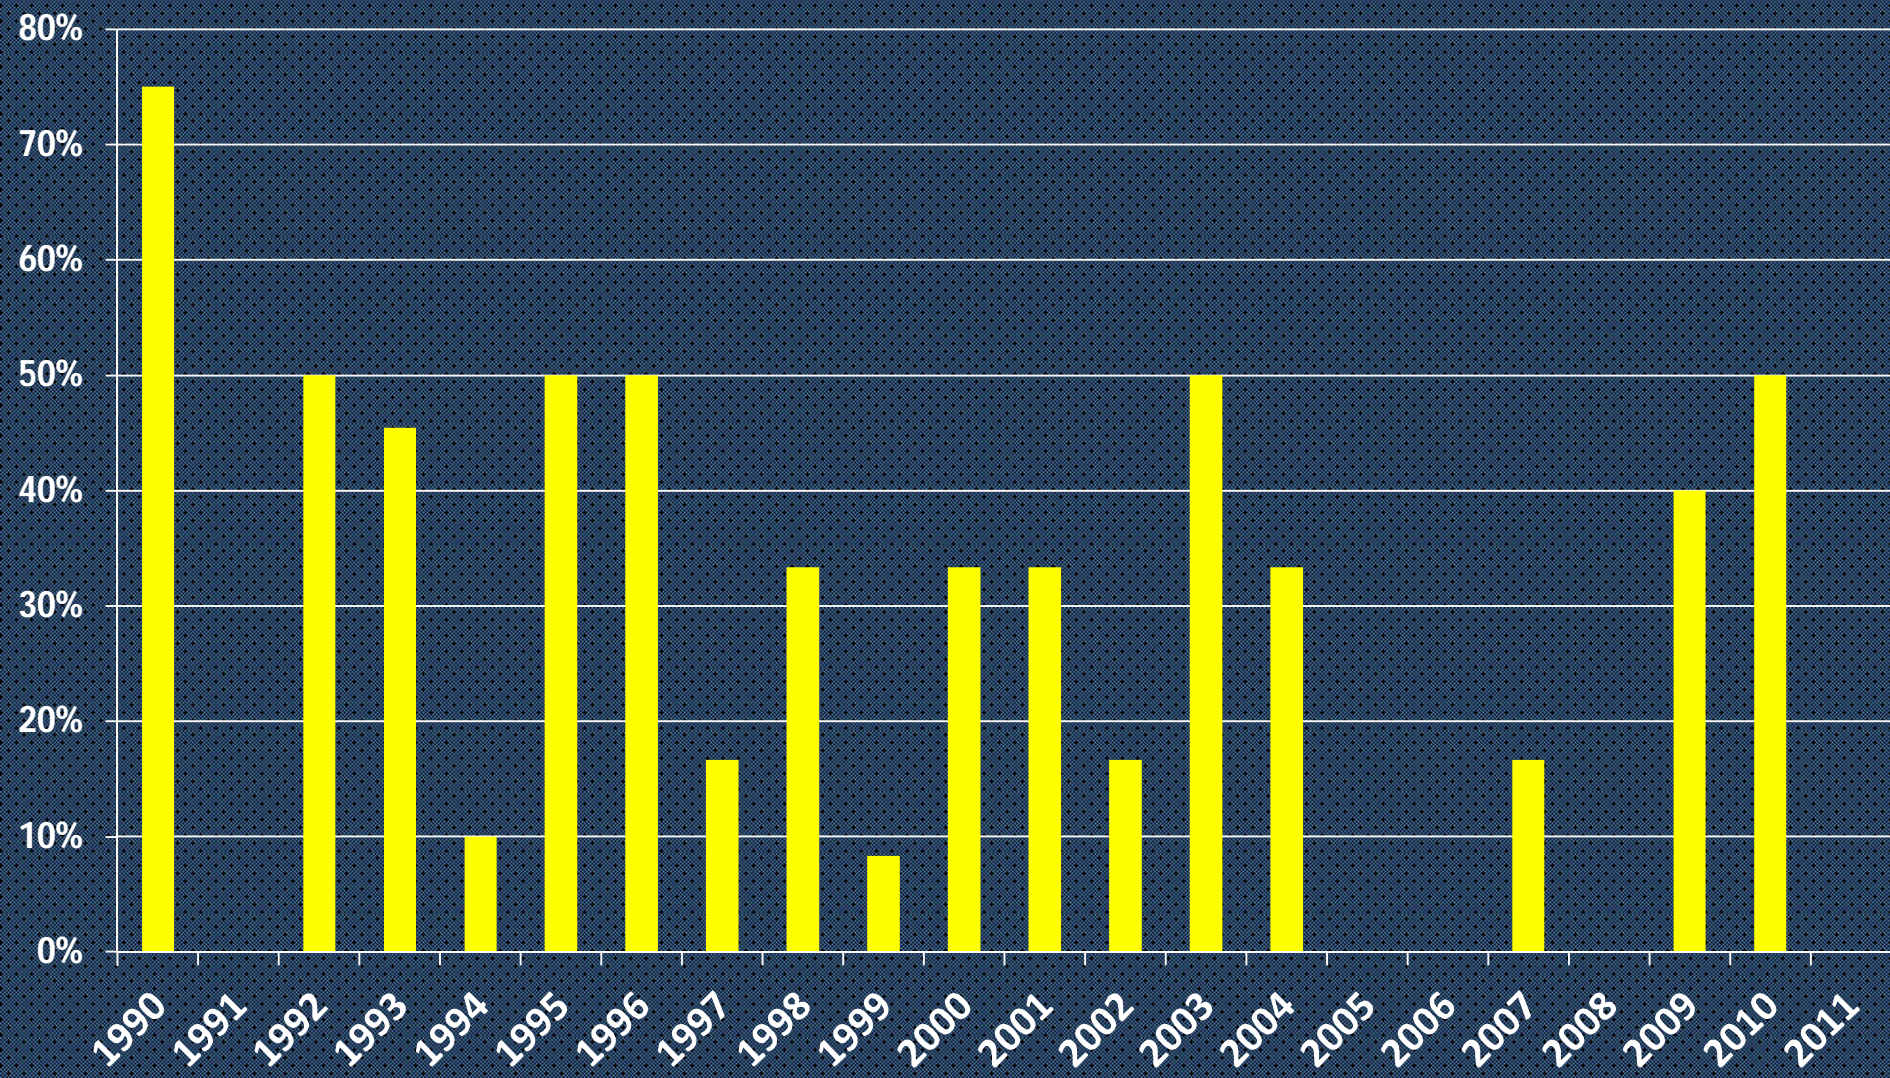
# Fecal Coliform Interim Standard (400 cfu/100 mL) Violation Rate at Big Otter River station 4ABOR000.62 (1990 – 2011)

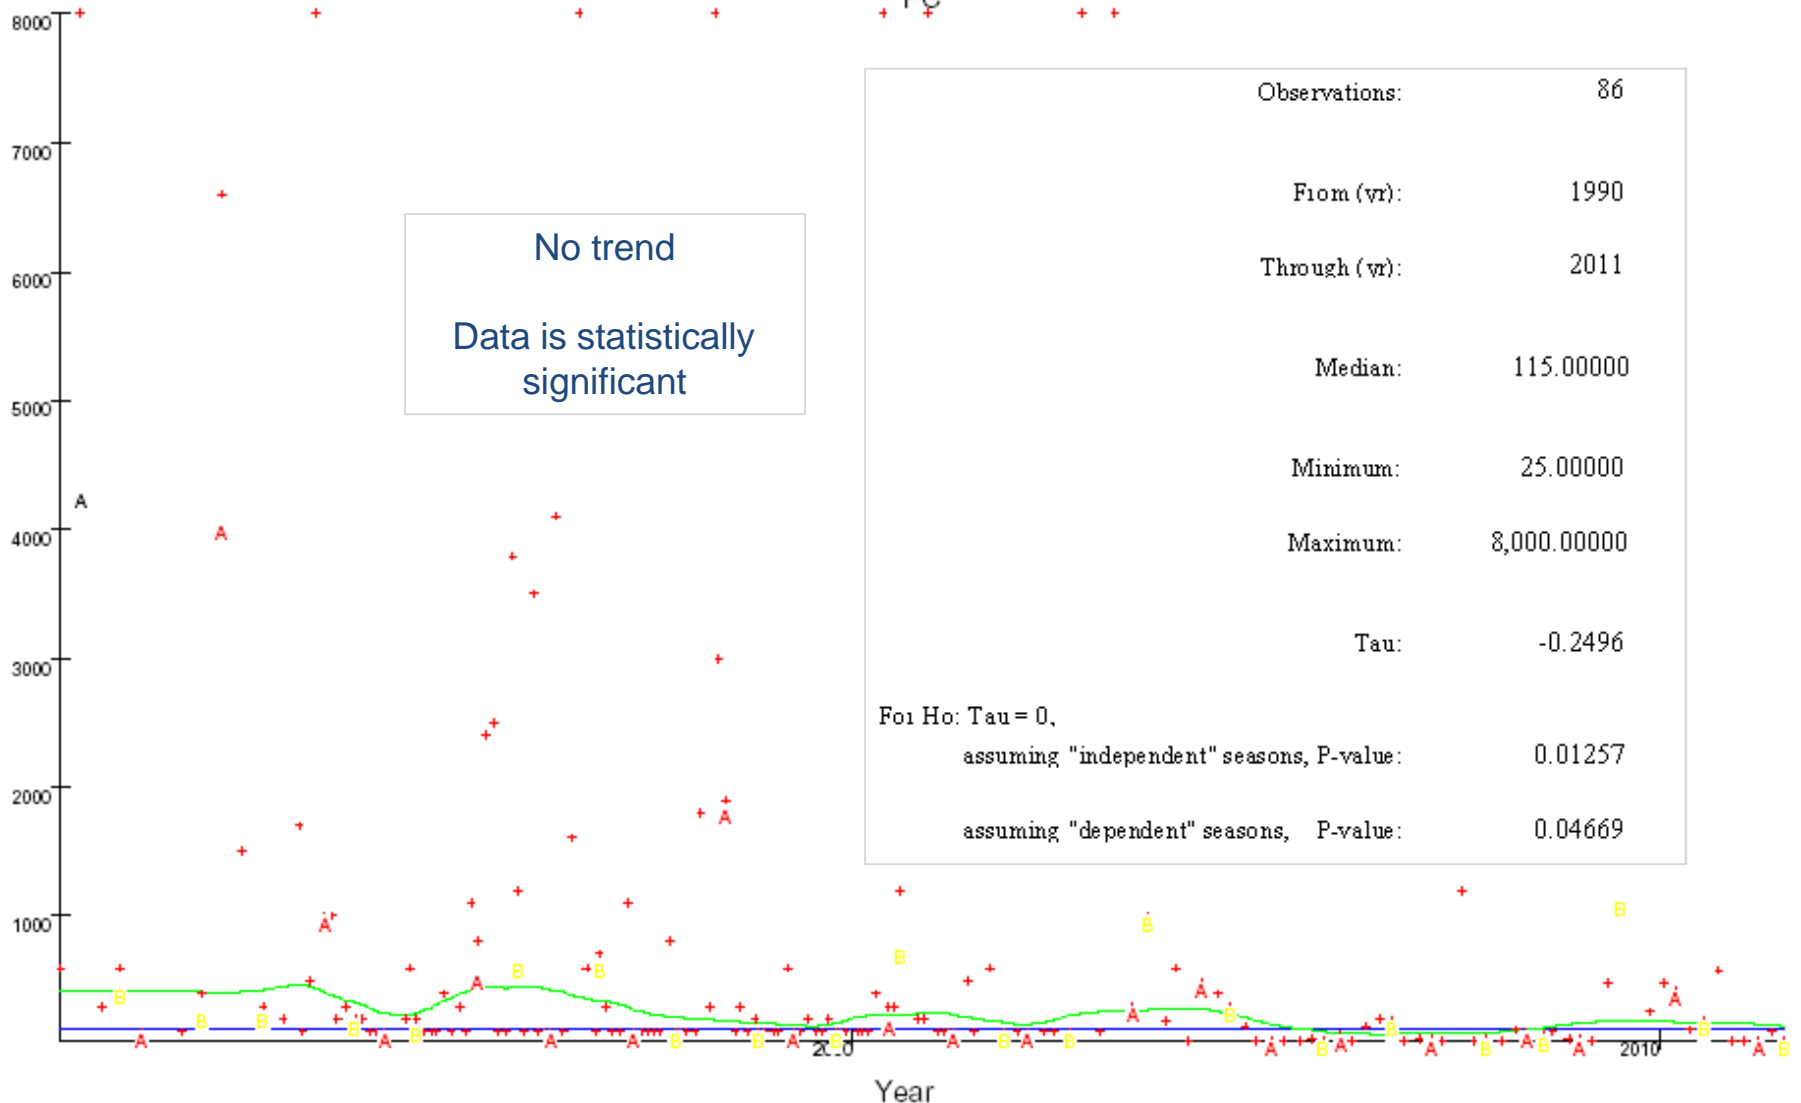
# Station 4ABOR000.62, FC

Tau = -0.263768, Ind-P = 0.067738, Dep-P = 0.130981, Slope = 0 (Record bor00062trend)

No trend

Observations: 86

Median: 115.00000

NOTE: Original Data are red. Reduced to medians data are colored symbols.

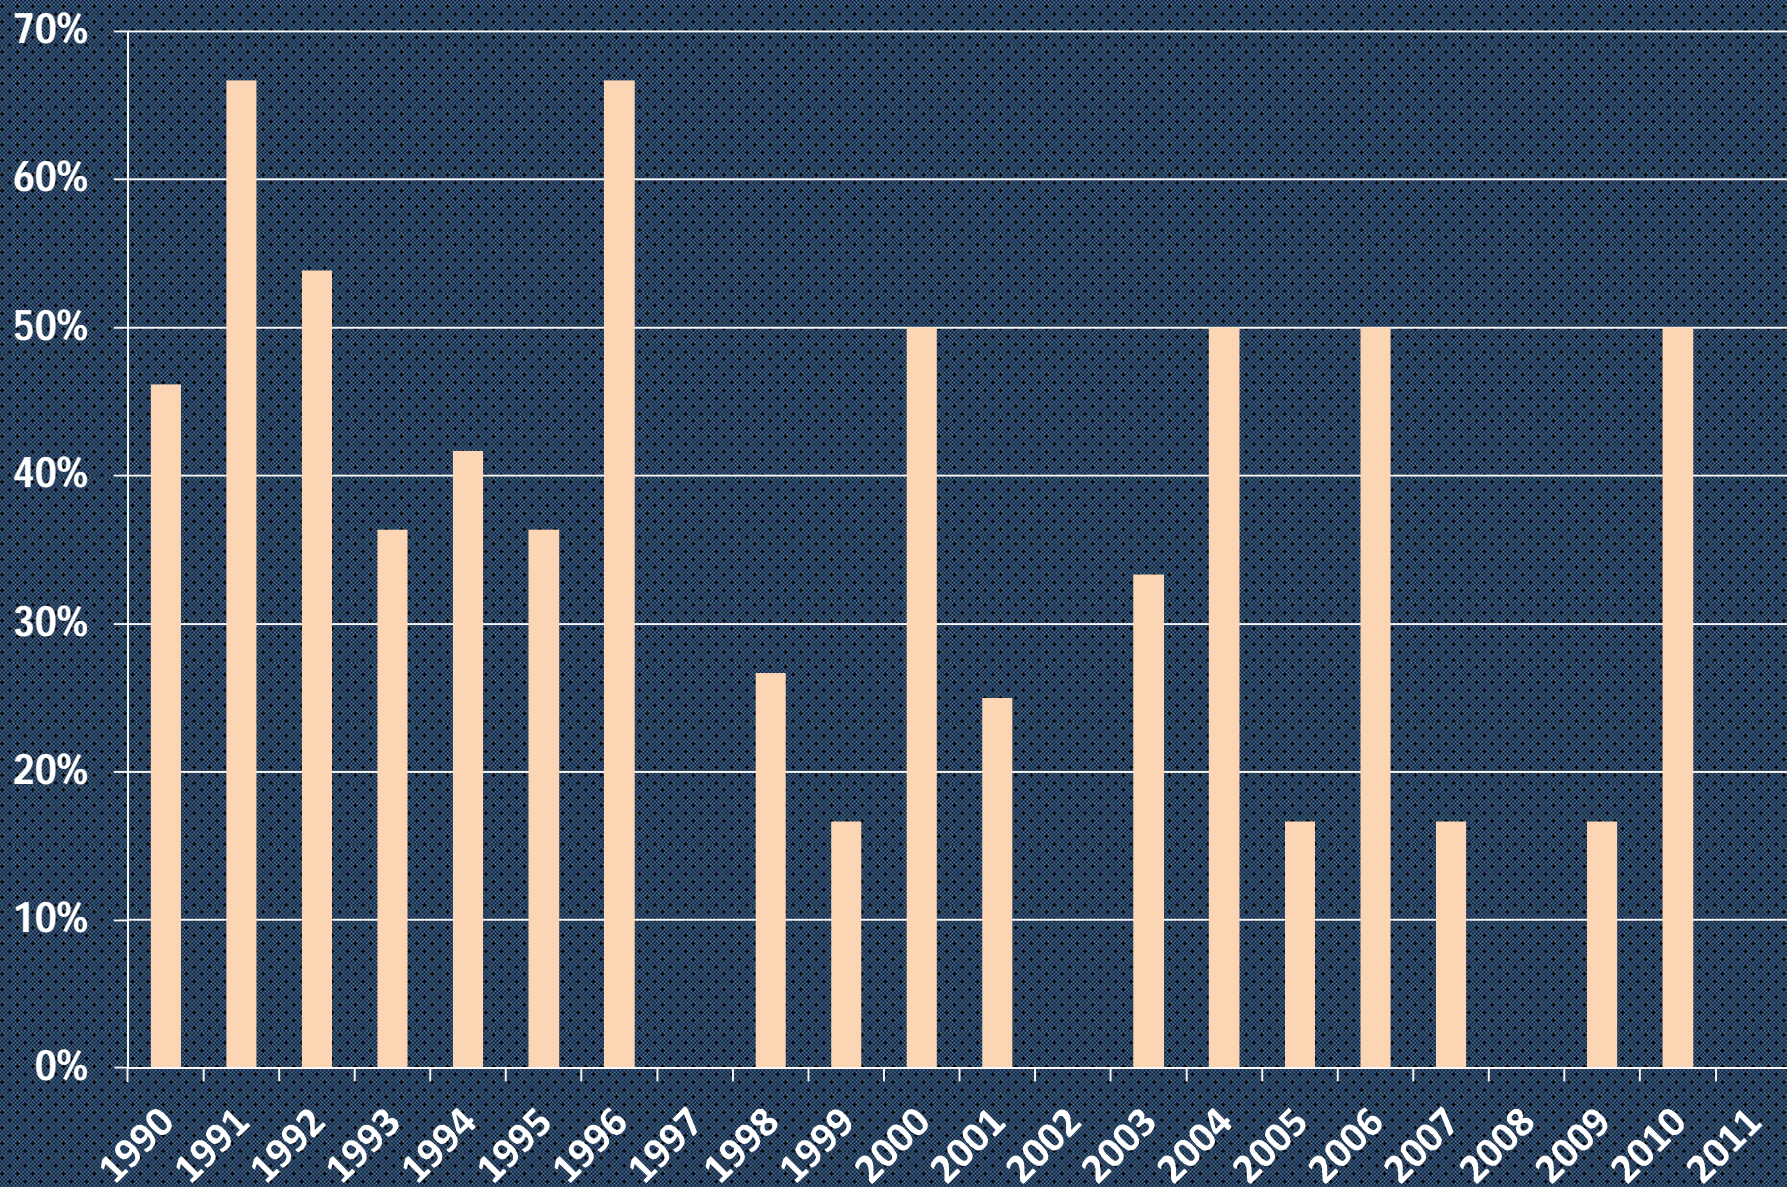
# Fecal Coliform Interim Standard (400 cfu/100 mL) Violation Rate at Little Otter R. station 4ALOR014.75 (1990 – 2011)
